Allied Paper, Inc./ Portage Creek/  
Kalamazoo River Superfund Site

## Former Plainwell Impoundment 2010 Bank Conditions Monitoring Report

Georgia-Pacific LLC

April 2011

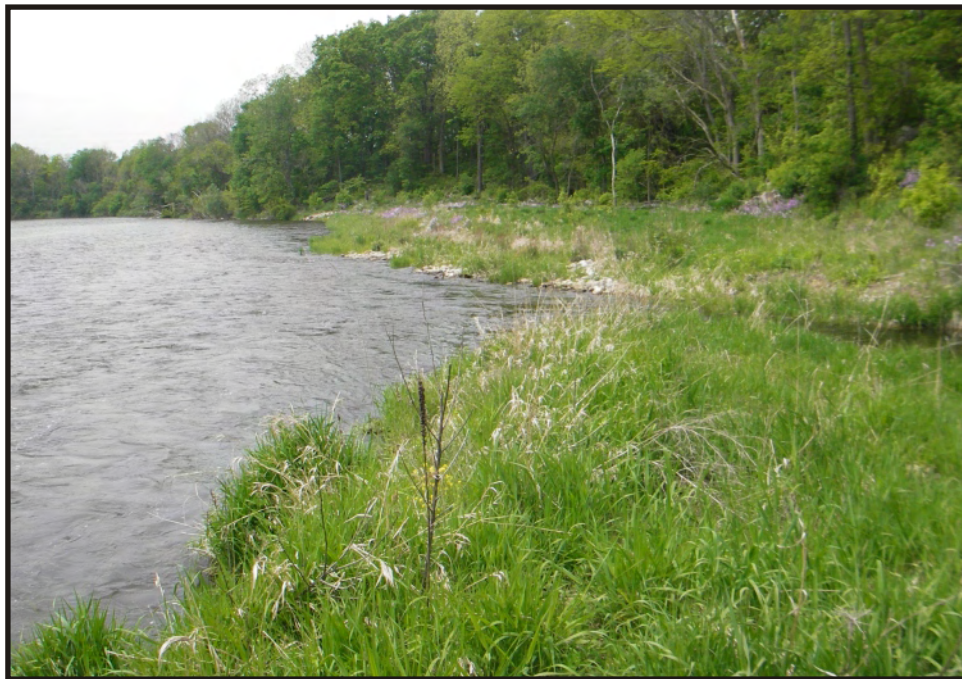
8

**Photo #8:** BEHI Area H on north bank immediately downstream of the US-131 bridge, looking northwest.

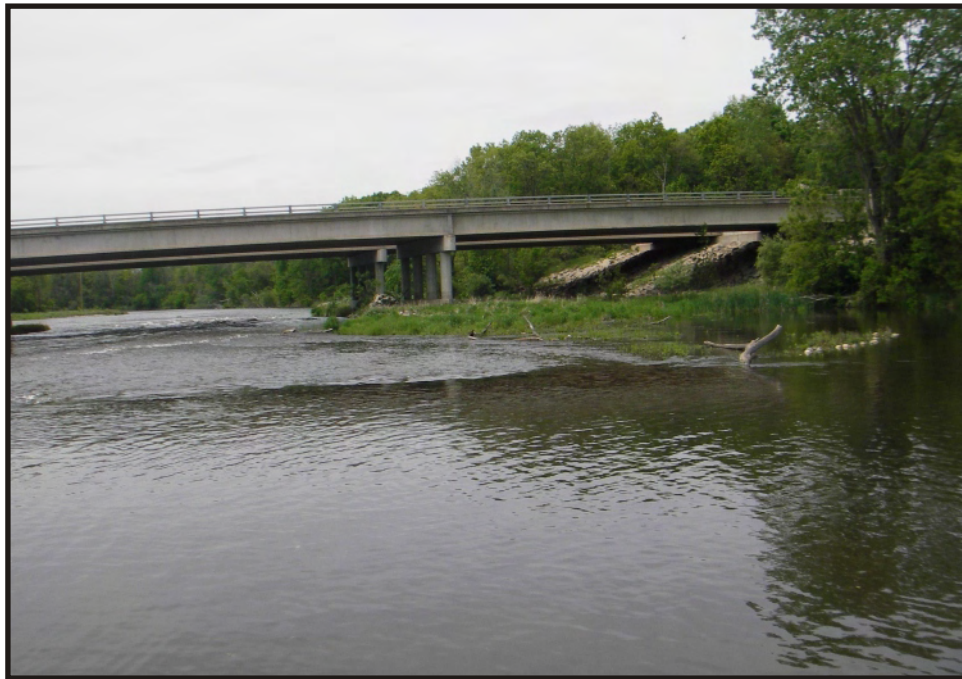
9

**Photo #9:** Island 3 on north bank, looking northwest from upstream.

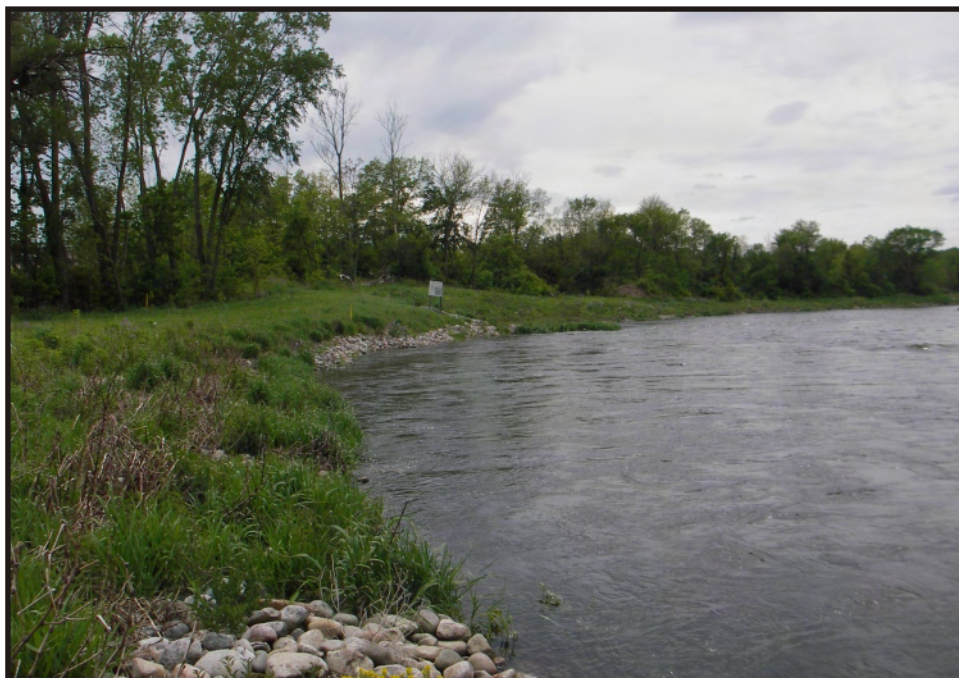
28

**Photo #28:** BEHI Area H on south bank, looking west.

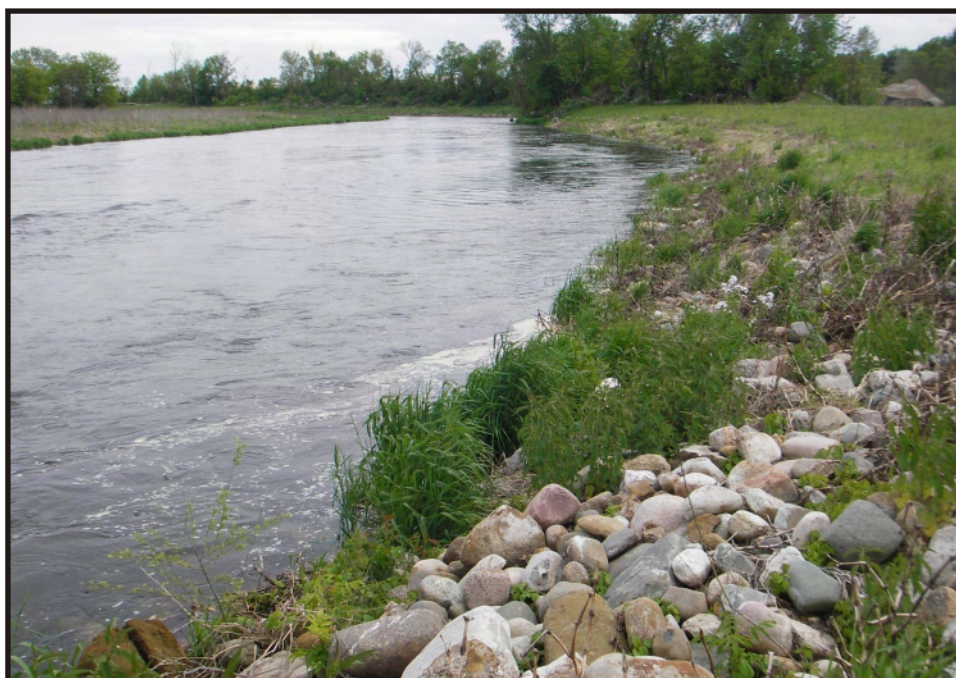
**34**

**Photo #34:** BEHI Area H on north bank at the former Plainwell Dam, looking northeast

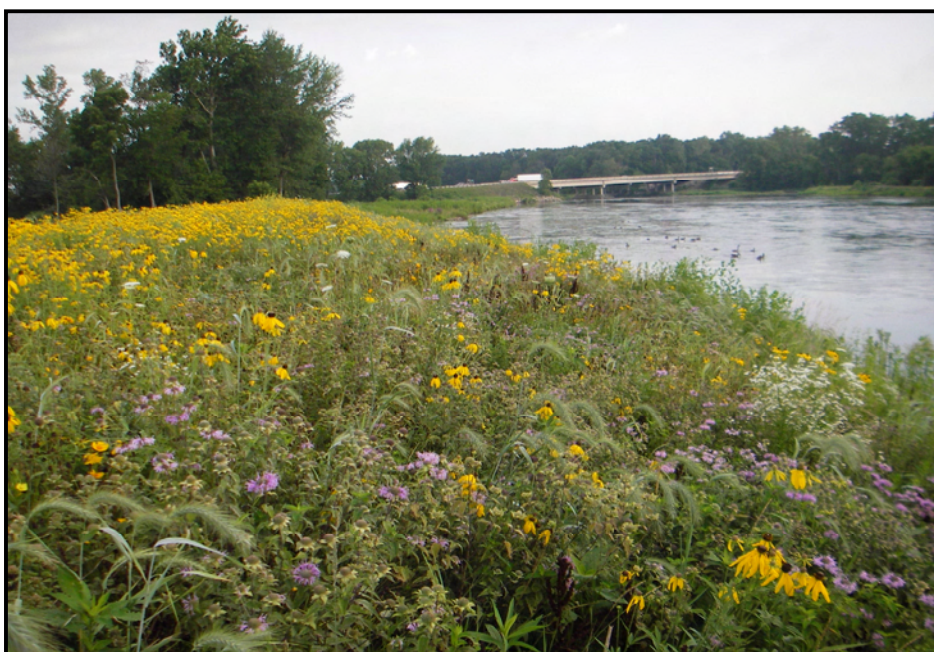
**15**

Photo #15: Vegetation of the upland portion of Removal Area 10B, looking southwest from the northeast corner.

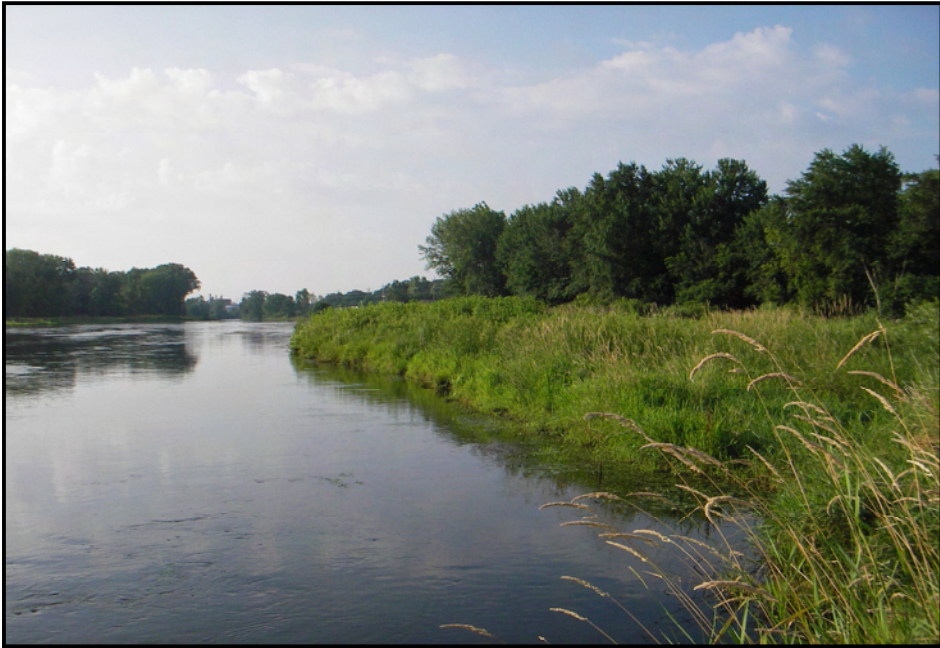
**16**

Photo #16: Vegetation of western portion of Removal Area 4B, looking west.

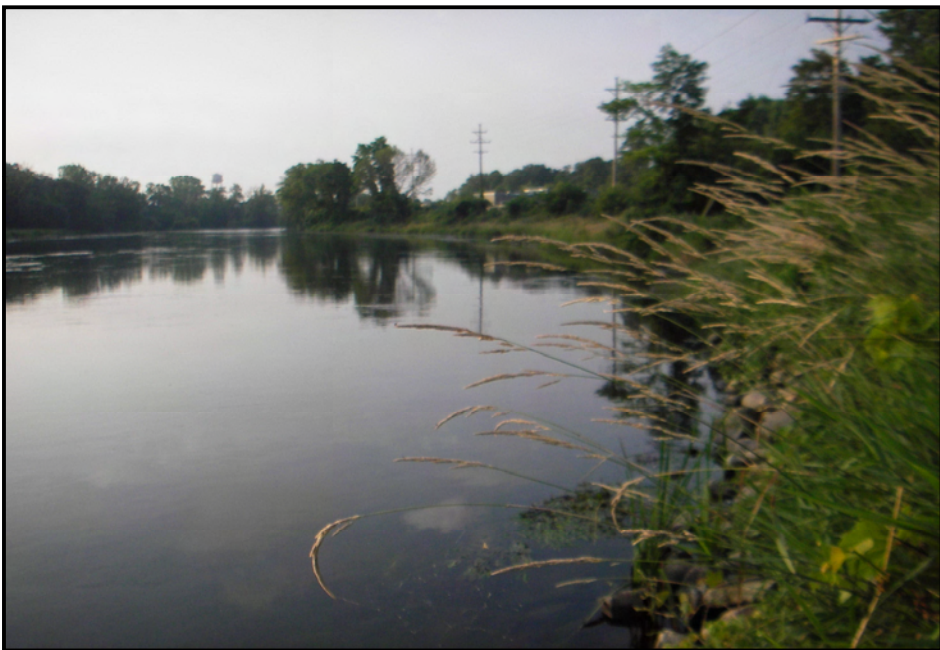
**17**

Photo #17: Vegetation of western portion of Removal Area 4B, looking east from west end.

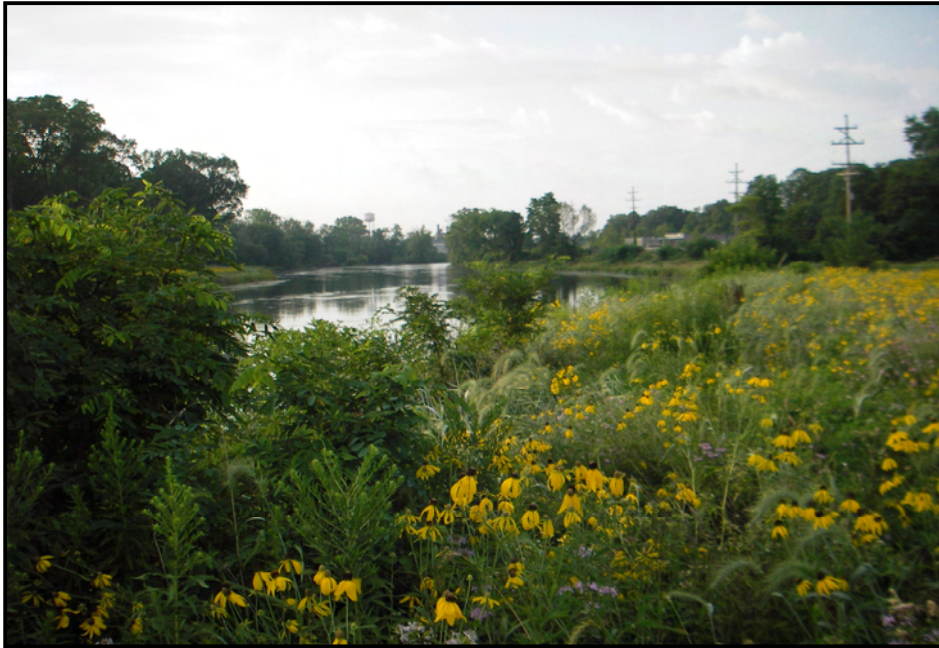
**18**

Photo #18: Vegetation of Removal Area 3B, looking east from west end.

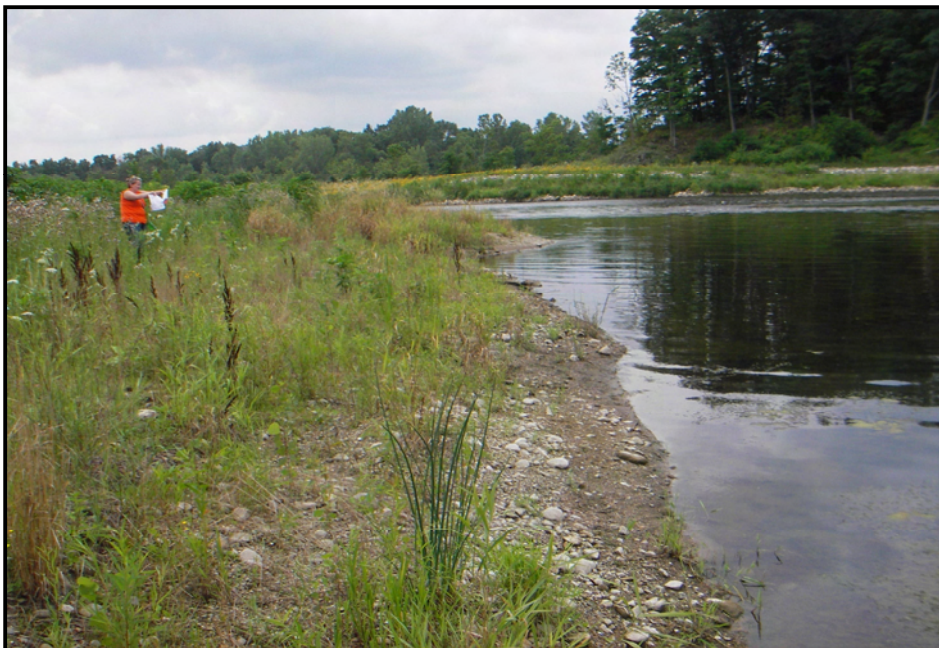
**19**

Photo #19: Vegetation of Removal Area 3B, looking east from center.

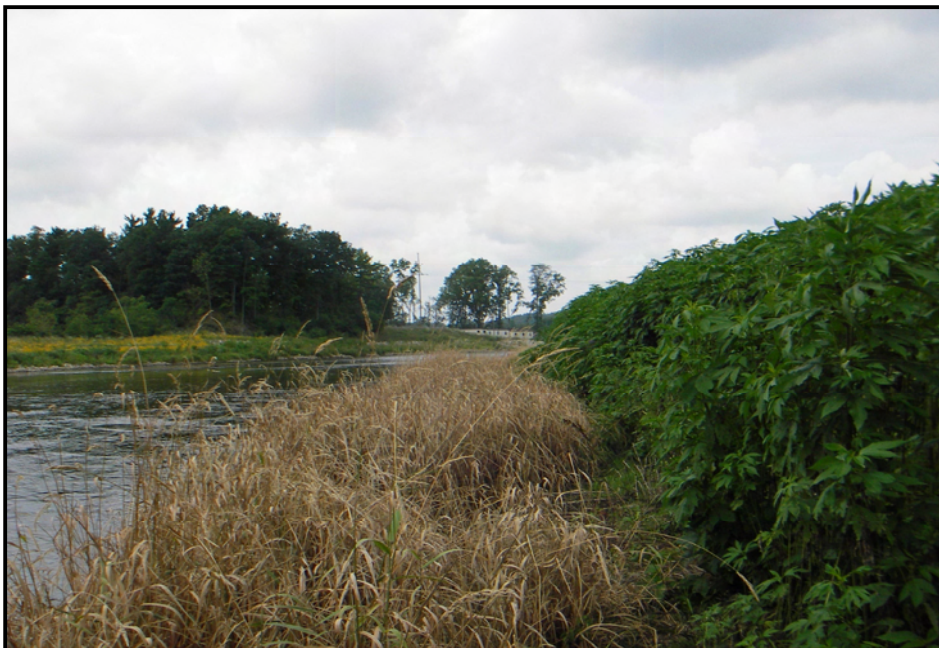
**20**

Photo #20: Vegetation of Removal Area 13A, looking southeast from former dam location

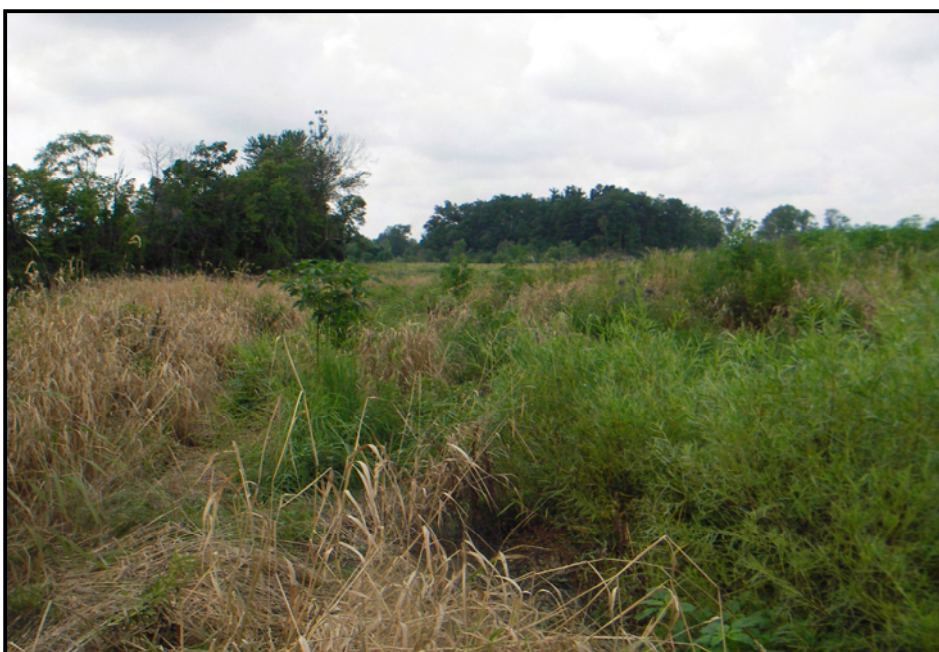
**21**

Photo #21: Vegetation of Removal Area 13A, looking west.

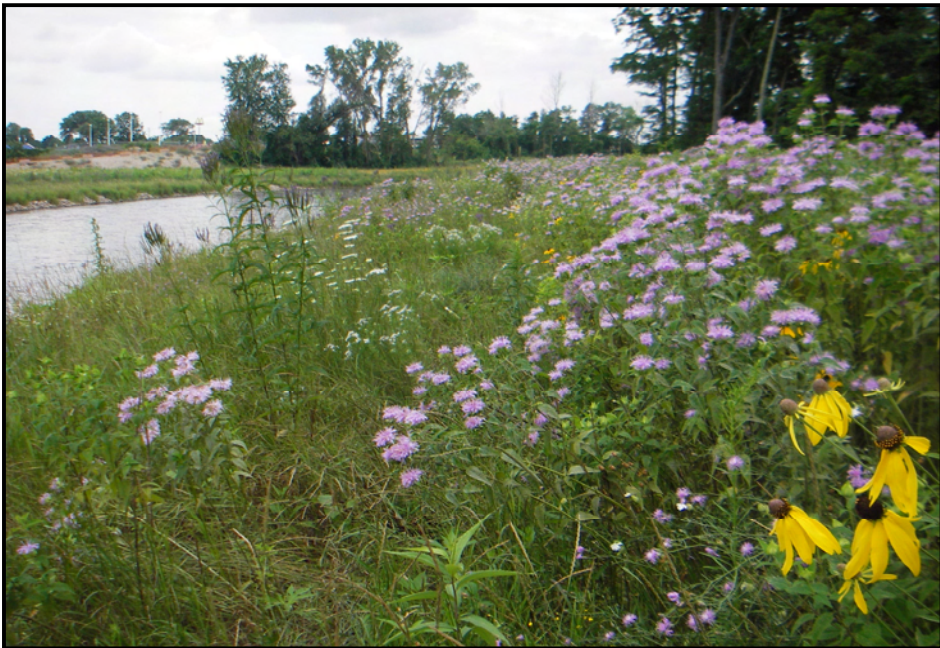
**22**

Photo #22: Vegetation of Removal Area 12A-1, looking west.

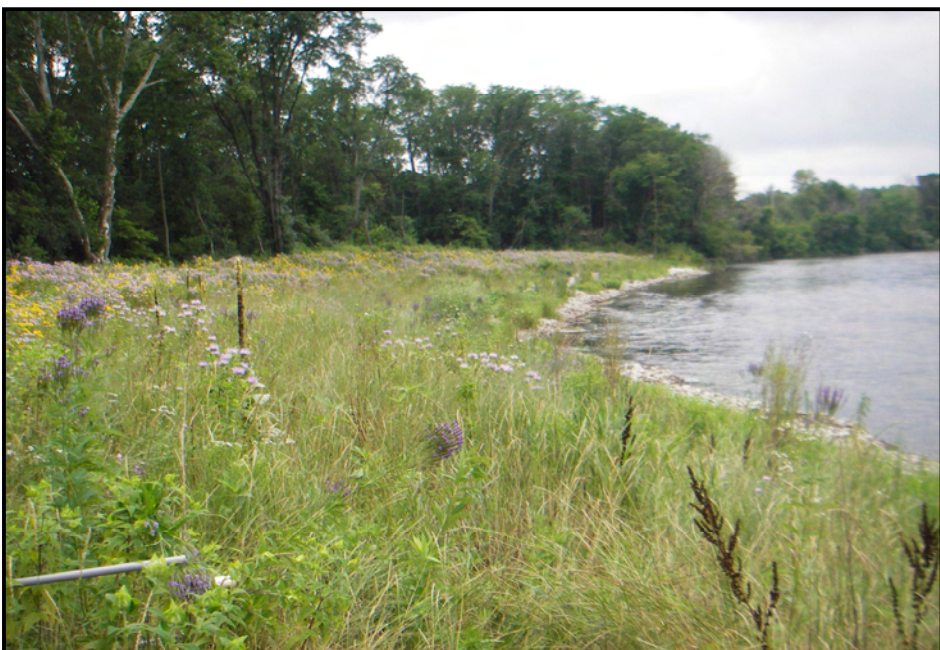
**23**

Photo #23: Vegetation of Removal Area 9A, looking west.

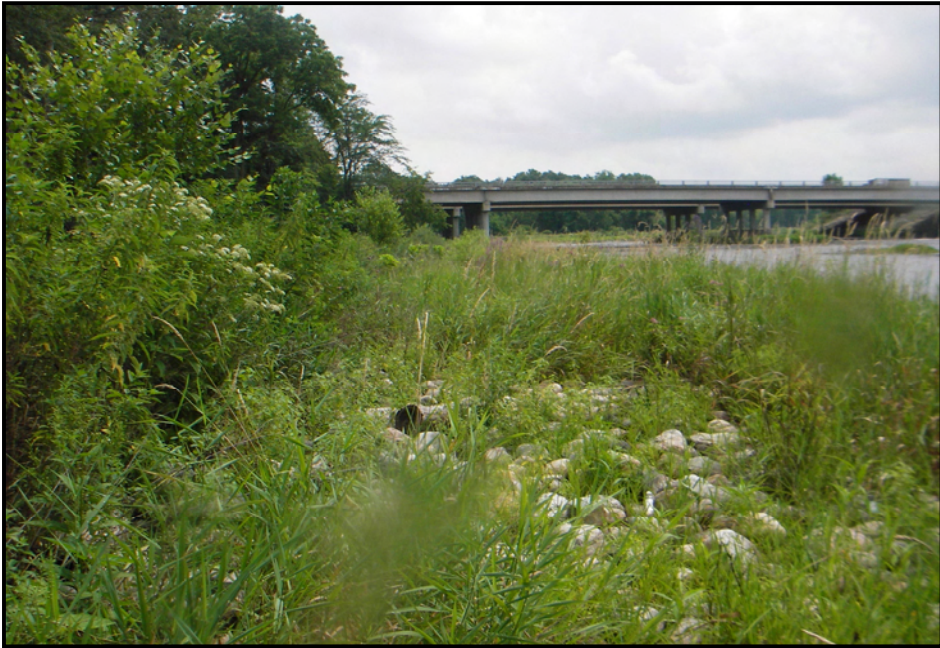
**24**

Photo #24: Vegetation of Removal Area 9A, looking east from west end.

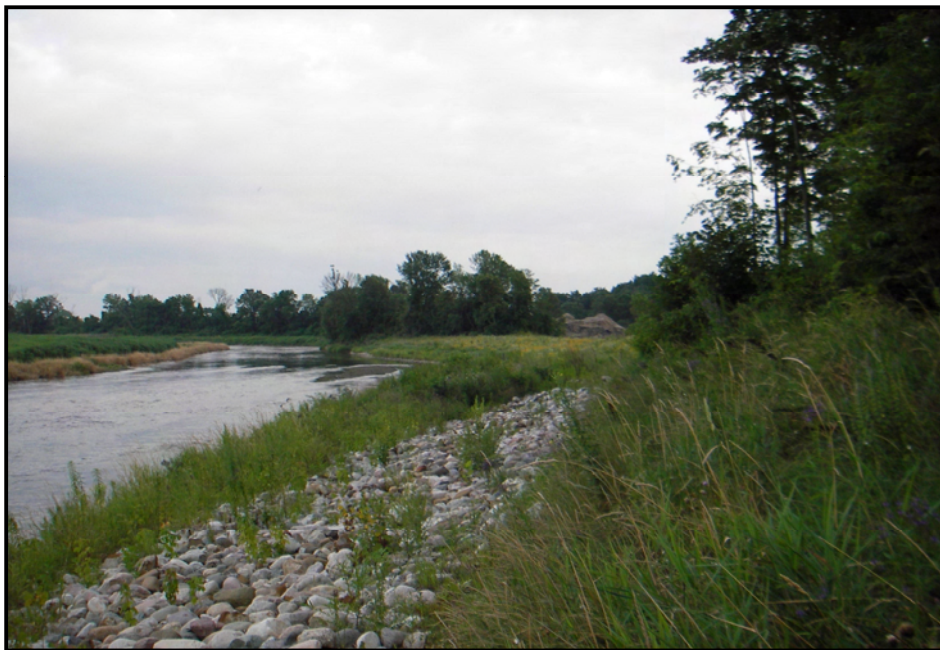
**25**

Photo #25: Vegetation of Removal Area 8A, looking east from west end.

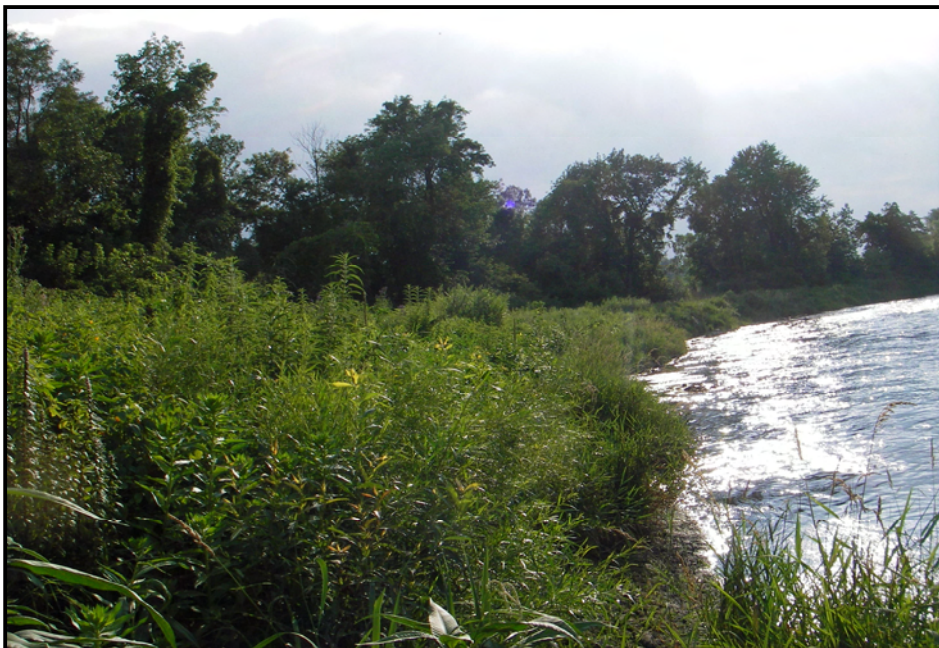
**26**

Photo #26: Vegetation of Removal Area 13B, looking east from west end.
